TFCC

精準臨床治療指引系統

| Wireframe & Mockup |

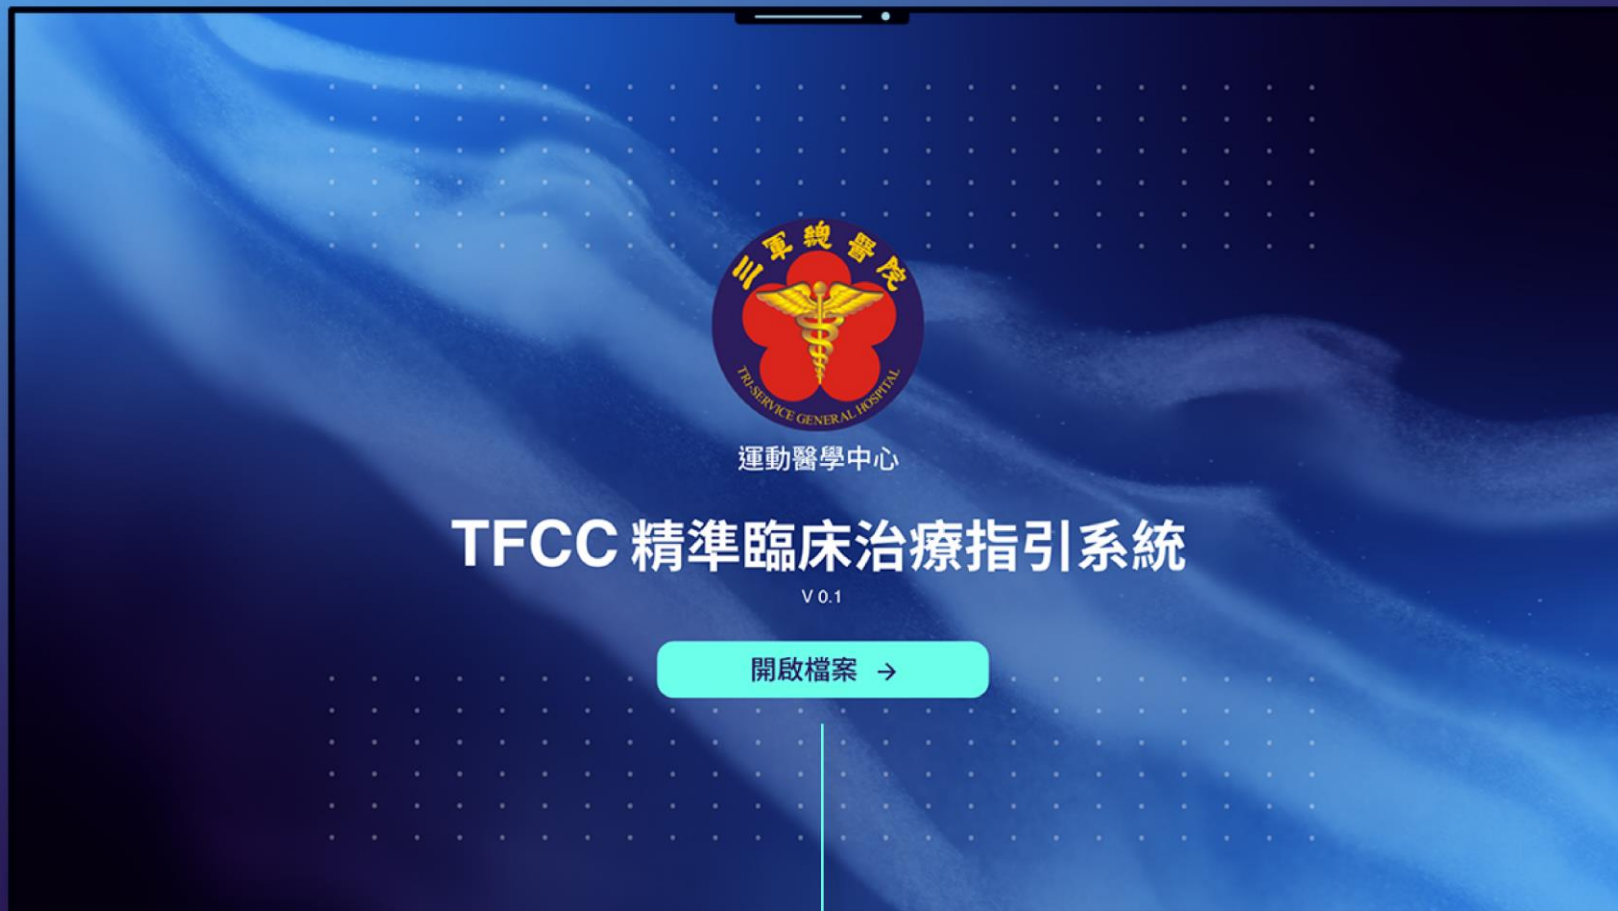
平台首頁

開啟檔案 →

按「開啟檔案」來開啟檔案清單
